Survey of the Regional Distribution and Status of Asbestos-Contaminated Construction Material and Best Practice Options for its Management in Pacific Island Countries

Report for the Independent State of Samoa

Prepared for the Secretariat of the Pacific Regional Environment Programme (SPREP)

May 2015

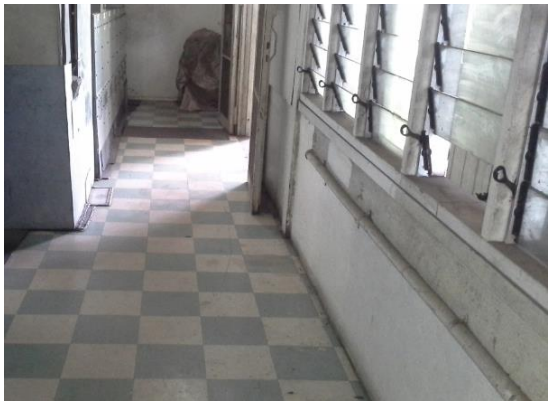
Photo 1 – Tuiala Power Station

Photo 1 below shows the vinyl tiles in the Tuiala Power Station which tested positive for a low level of chrysotile. Photo 2 below shows the ceiling panels at the Femei Matafa Office of Statistics which tested positive. There may be other ceiling tiles containing asbestos in this building.
